**Flood Control Project Maintenance
Levee Inspections**

Fall 2010 Levee Maintenance Deficiency Summary Report

Sacramento Maintenance Yard Sacramento Bypass

Levee Inspection Report By Mile - Fall 2010

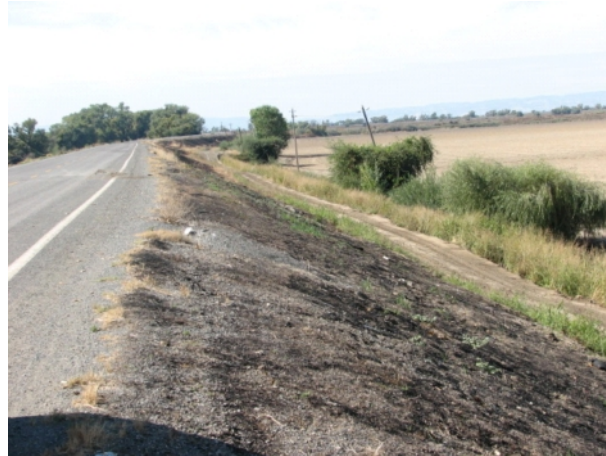
Levee Mile Report Line	2
Start Levee Mile	0.50
End Levee Mile	0.50
Location	Land Side
Category	Earthen Levee
Item	Vegetation
Landside levee slope at .50 after burning.	
johngw_f_20101117_339.jpg

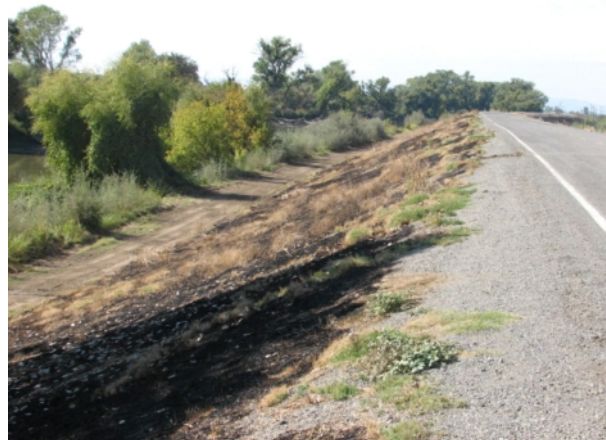
Levee Mile Report Line	3
Start Levee Mile	0.50
End Levee Mile	0.50
Location	Water Side
Category	Earthen Levee
Item	Vegetation
This is the waterside slope at .50 LM.	
johngw_f_20101101_285.jpg

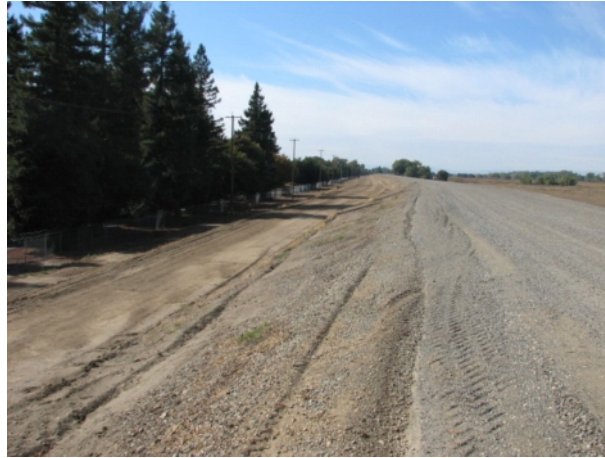
Levee Mile Report Line	1
Start Levee Mile	0.00
End Levee Mile	0.00
Location	Land Side
Category	Earthen Levee
Item	Vegetation

Photo is of the landside levee slope behind the CHP and the new berm placed last summer.

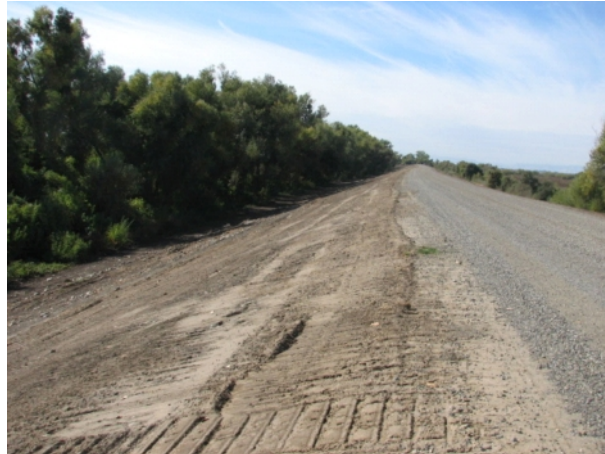
Levee Mile Report Line	2
Start Levee Mile	0.75
End Levee Mile	0.75
Location	Land Side
Category	Earthen Levee
Item	Vegetation

Photo of the landside of the levee slope.

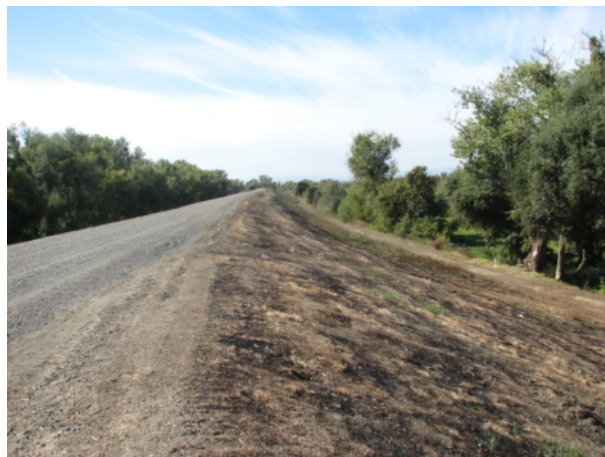
Levee Mile Report Line	3
Start Levee Mile	0.75
End Levee Mile	0.75
Location	Water Side
Category	Earthen Levee
Item	Vegetation

The levee slope has been burned view is the waterside at .75 LM.

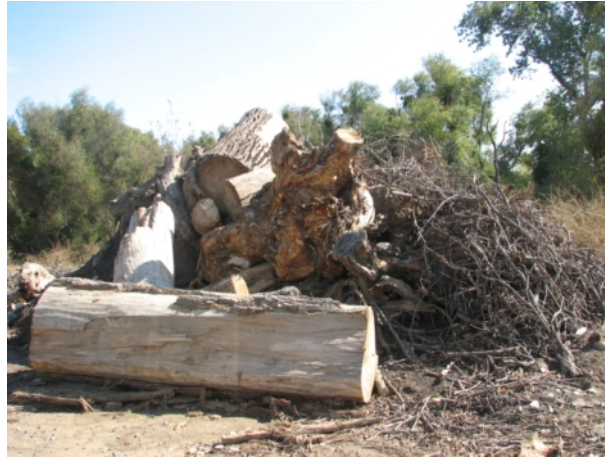
Levee Mile Report Line	4
Start Levee Mile	1.76
End Levee Mile	1.76
Location	Land Side
Category	Earthen Levee
Item	Encroachments

This is an on going burn pile at the end of the unit that gets burned a couple times a year.
